TRACING DEVELOPING DETERIORATION ZONES IN A DAMAGED DAM BY USING ELASTIC WAVE TOMOGRAPHY

Paper ID: 1169

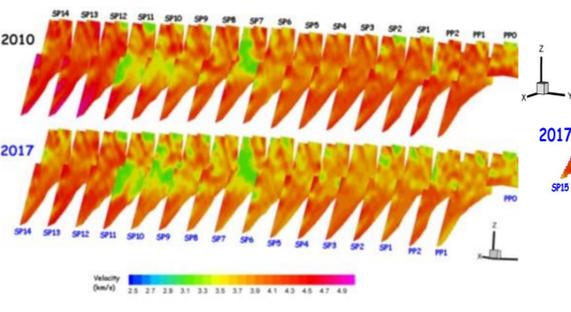
Dam Pillars

Most of concrete conditions are classified as the questionable or good level (3,000~4,500 m/s). In total, the lowest velocity zones (lower bound 3,000 m/s of questionable level Q) are significantly identified on pillars SP7, SP10, and SP11, but the reduction is <6%. The original lowest velocity zones in 2010 expanded into the inner portion of dam pillars, especially PP0, PP2, SP1, SP2, and SP6~SP10, in 2017.

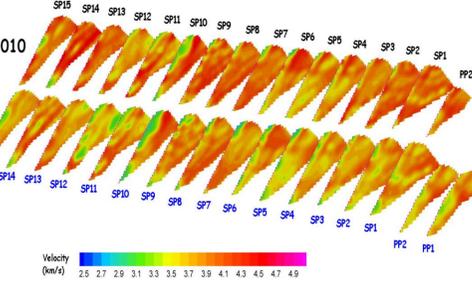
Spillways

Most of concrete conditions are classified as a questionable or good level (3,000~4,500 m/s). The original low velocity zones in 2010, especially SP1~SP12 expanded in 2017, and the total velocity reduction is <12%.

- Overall wave velocities decrease, but quality is identified as a good (G) or questionable (Q) level, approaching the lower bound of questionable level (3,000~3,200 m/s).
- The surface low velocity zone expands deeper up to 2~3 m. Several limited low wave velocity belts spread and form a relatively low wave velocity zone.
