OVERWATER DEPTH INSPECTION ON A SUBMERGED PILE BENT

Paper ID: 1100

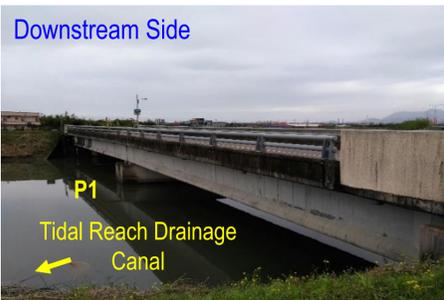
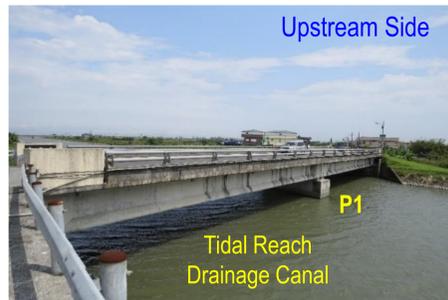
In order to accelerate the bridge construction speed, pile bents (i.e., partially embedded concrete piles) were used for crossing over the drainage canal full of soft clay and silty sand. The pile bents were composed of two cast-in-place piles (drilled shafts) with a diameter of 1.5 m and a length of 31.8 m. The exposure height beyond the riverbed was designated as 1.8 m below the pier cap bottom at its design phase. The varying tidal level significantly traced back to the upstream, caused the riverbed variation, and also led to the water table approaching the pier cap bottom at its highest tidal level.

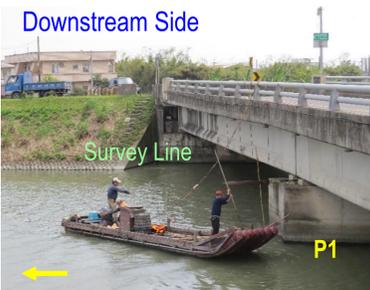
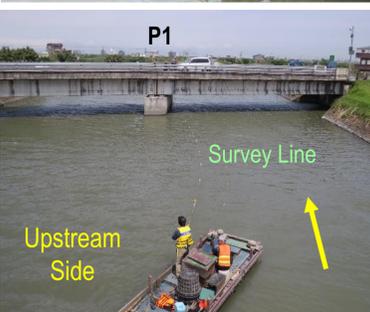
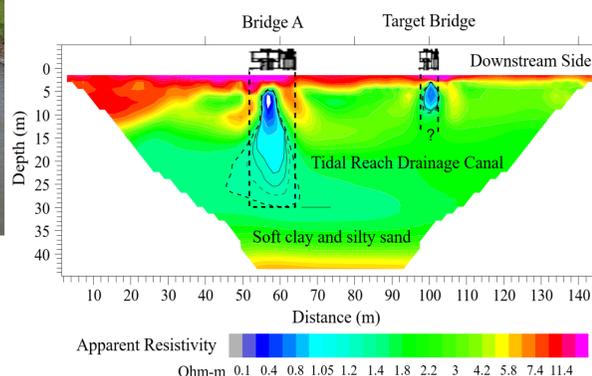
Utilizing SYSCAL Pro, Switch Pro, termination strip, and electrode probes to display the electronic potential field on the target bridge. Low resistivity closed contours are right at pile bent locations. The bridge depth was identified as 10 m (<<designated length, 31.8 m). Repeated scour and deposits weakened the interface among saline water, soft soils, and piles bents. The resistivity effect on the deeper pile bent was masked with salt-content materials at the shallow canal.

1. A high salinity in riverbed soils and water weakens the overwater electrical resistivity tomography ability.
2. The modified ultra-seismic inspection technique provides more flexible installation for evaluating the condition of completely-submerged pile bent foundations.
3. The conventional lapsed-time waveform image analysis has a wider range of length prediction values. The determination of unknown pile bent lengths is highly dependent upon investigator's experience & judgement.
4. Based on the one-dimensional wave theory, the frequency analysis provides a relatively reliable length estimate by using the average frequency span between two adjacent resonant frequencies.
5. The entire set of investigations demonstrates the conclusiveness in determining the foundation depths when the results from testing methods are corroborated with appropriate analysis modes.

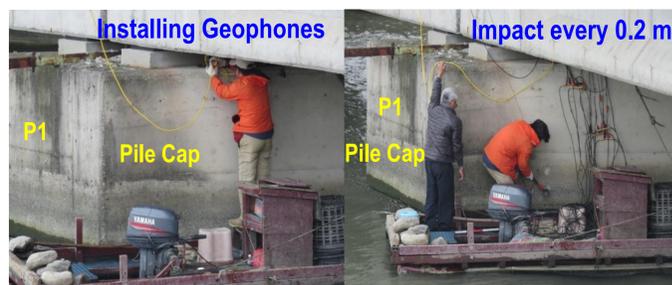
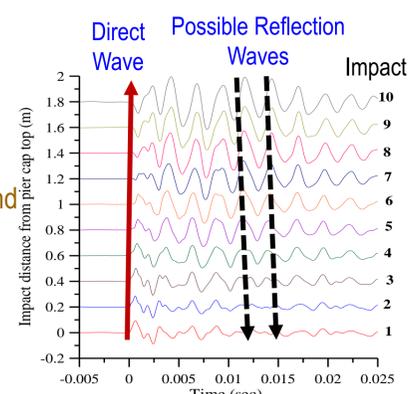
The ultra-seismic waveform (**lapsed-time analysis**) shows that the pile bent length, 25.51~34.52 m. The precision of a plot-based approach is affected by overlapping echoes, waveform identification, inconsistent responses, and installation quality.

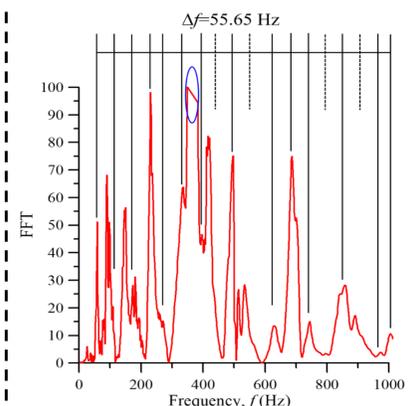
The 1-D **frequency analysis** provides a relatively reliable length estimate (34.44 m; 2.5% error) by using the average frequency span between two adjacent resonant frequencies.

$$L = C_{bar} / (2\Delta f)$$
