TRACING DEVELOPING DETERIORATION ZONES IN A DAMAGED DAM BY USING ELASTIC WAVE TOMOGRAPHY

Paper ID: 1169

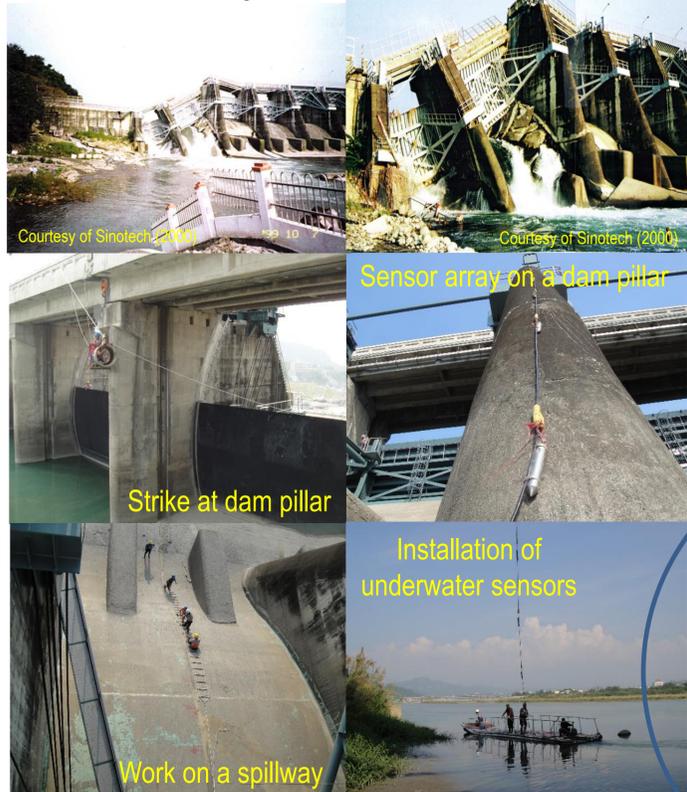
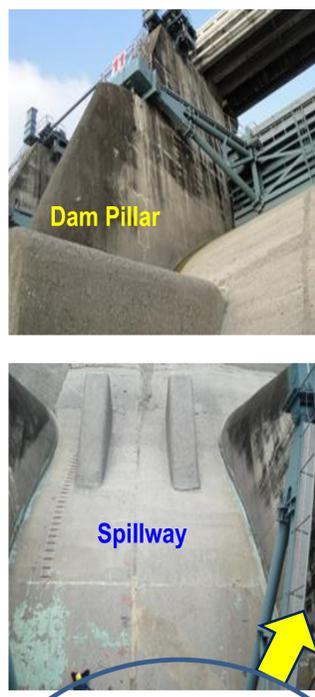
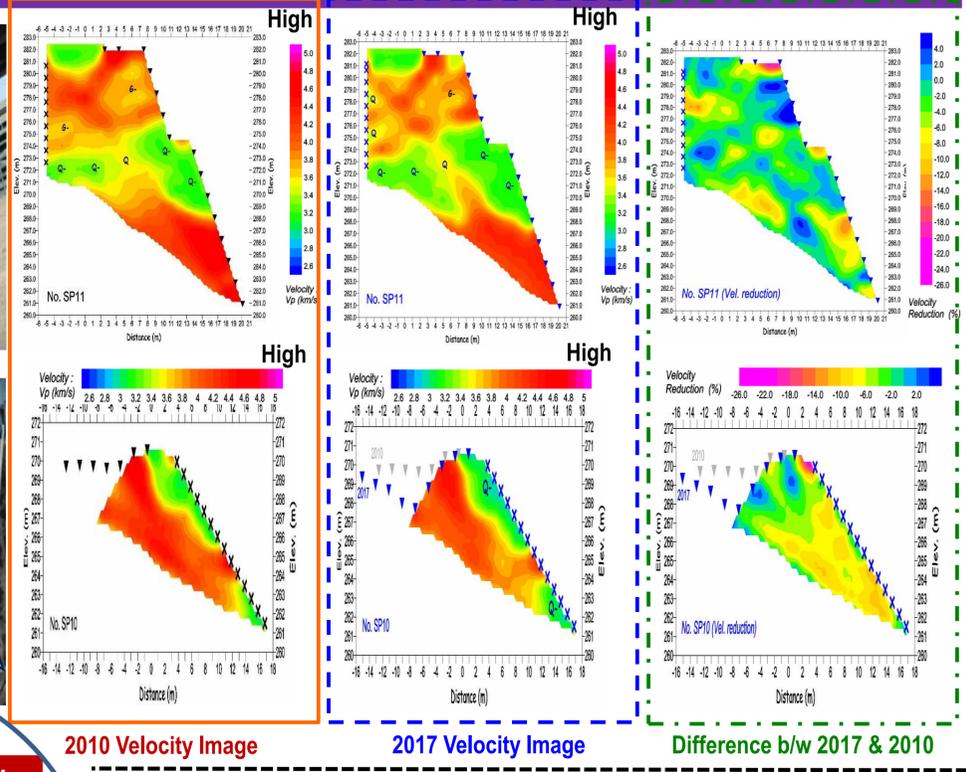
The concrete gravity dam in central Taiwan was constructed for providing drinking water in 1977. The Chi-Chi Earthquake triggered the nearby fault extended to the right bank of the river, lifted the ground surface up to 2.2 m, completely crashed 3 spillways, and structurally damaged the remaining facilities in 1999. An emergency rehabilitation plan was finished in 2000. Currently, the improved dam consisted 2 scouring sluiceways, 15 spillways, and one fish way.

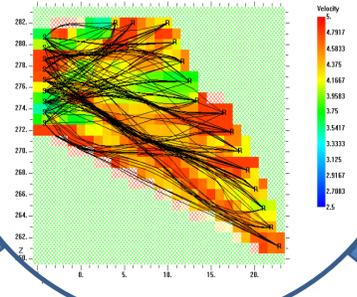
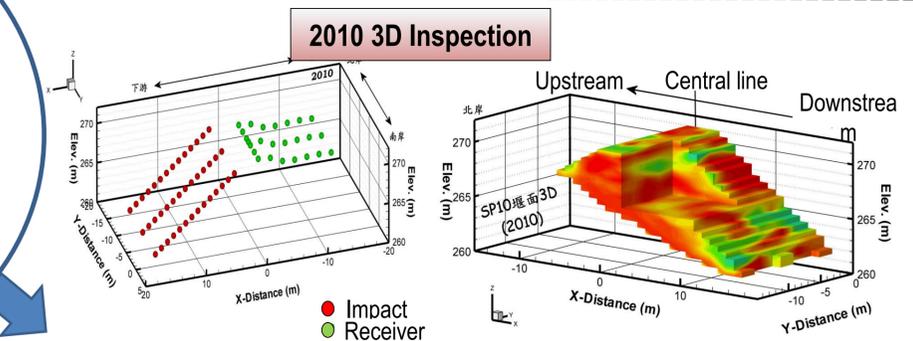
Most of concrete conditions are classified as the questionable or good level (3,000~4,500 m/s). In total, the lowest velocity zones (lower bound 3,000 m/s of questionable level Q) are significantly identified on pillars SP7, SP10, and SP11, but the reduction is <6%. The original lowest velocity zones in 2010 expanded into the inner portion of dam pillars, especially PP0, PP2, SP1, SP2, and SP6~SP10, in 2017.
